# Study on shelter response of Caritas Bangladesh for the Forcibly-Displaced Citizens of Myanmar

April-June 2018

September 2018

*Report prepared by CRAterre in collaboration with Caritas Bangladesh, Catholic Relief Services (CRS) and Bangladesh University of Engineering and Technology (BUET)*

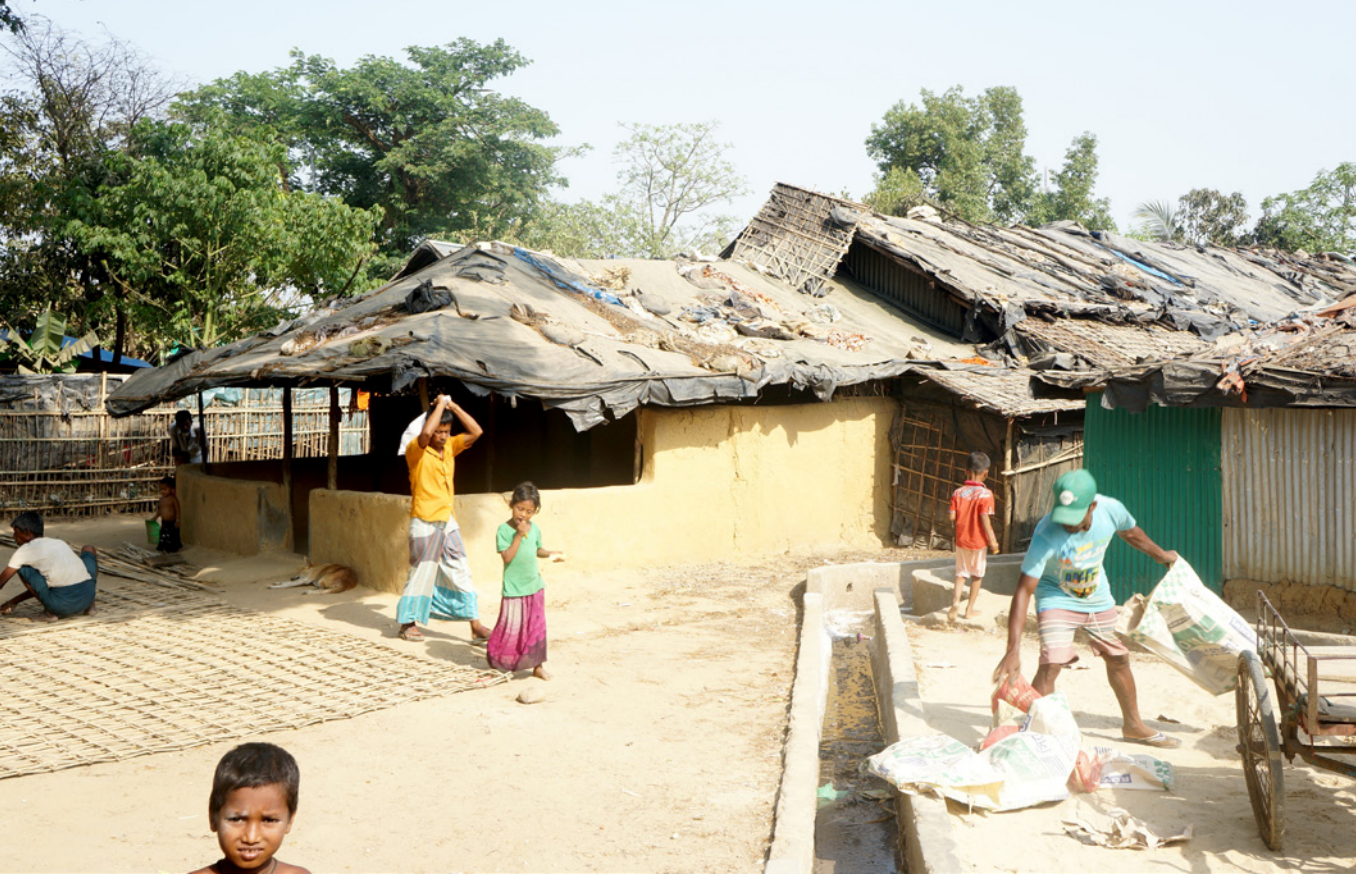
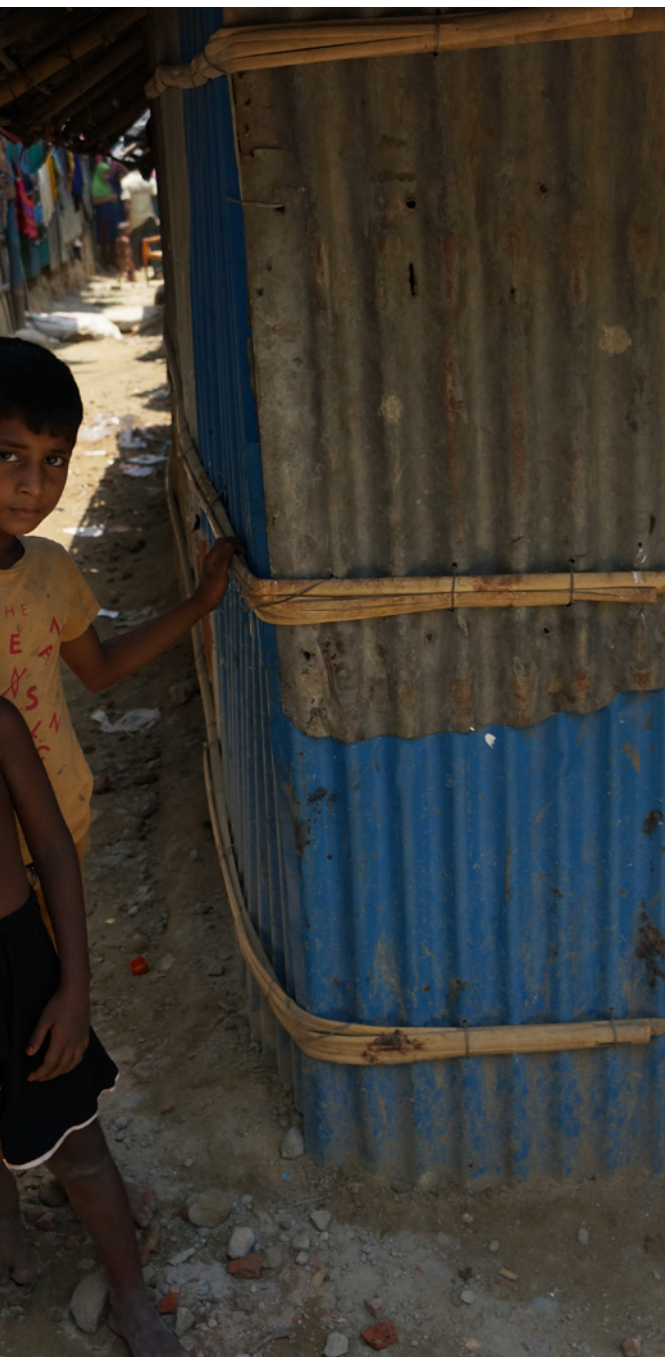
*Top:  
 Roof maintenance is the major problem for households  
 Left :  
 CGI fence needs frequent replacement and fixings  
 Right:  
 Pest attack on bamboo rafters*

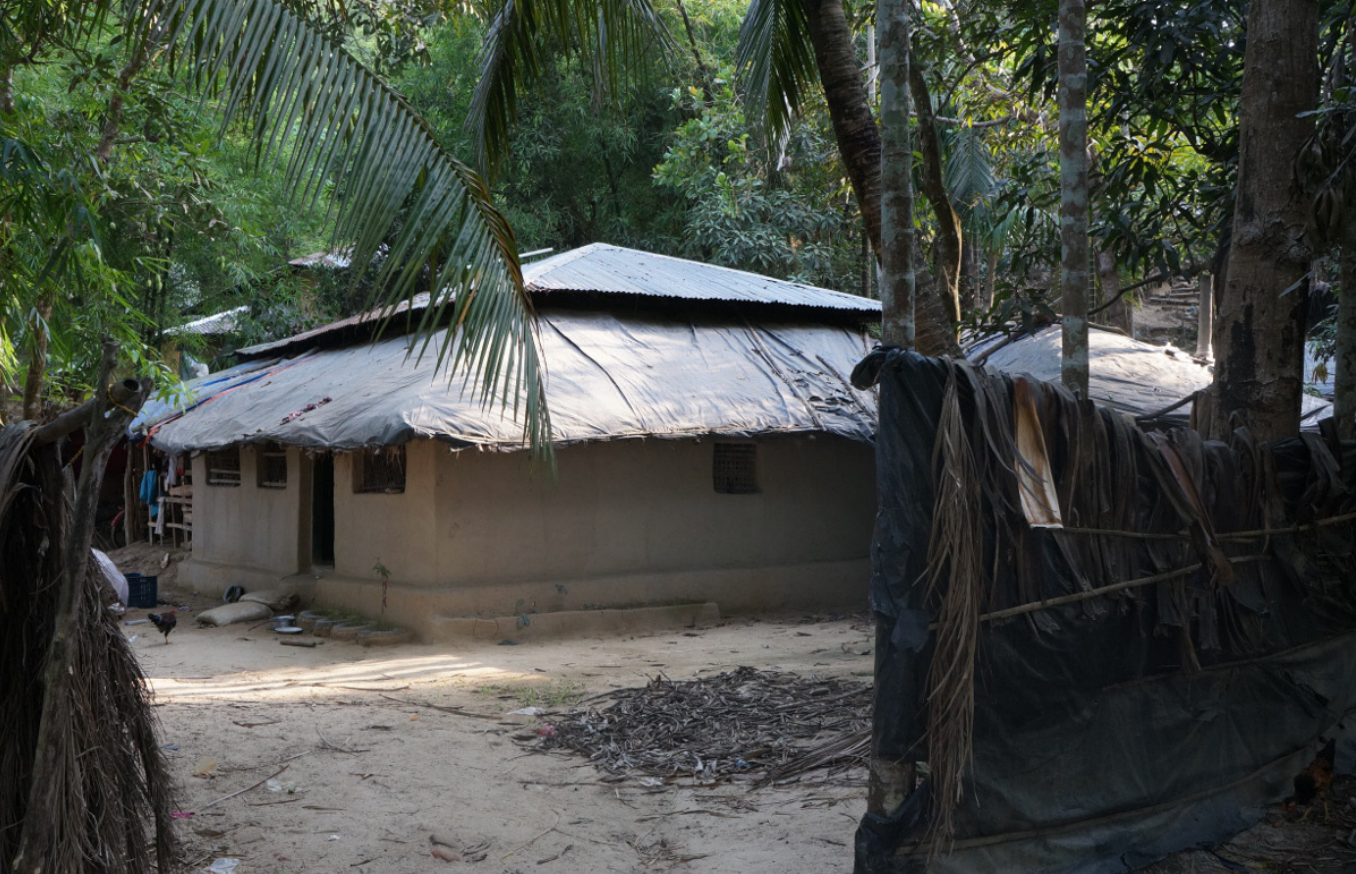
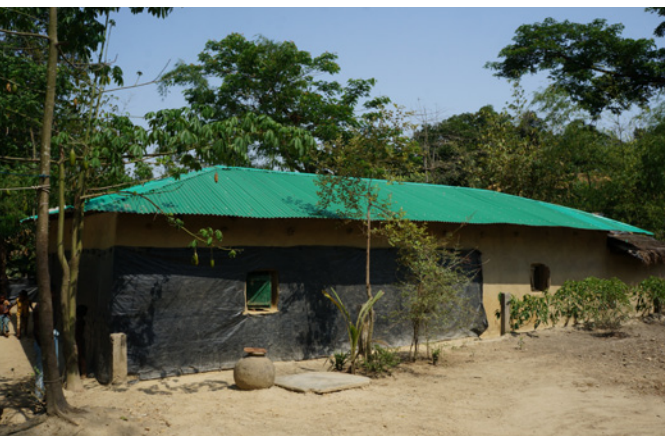
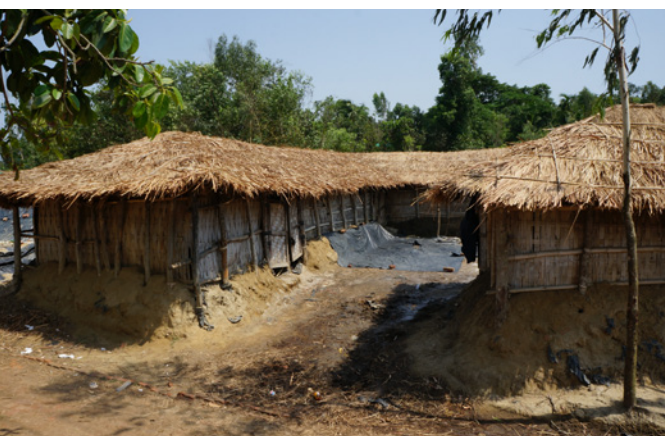
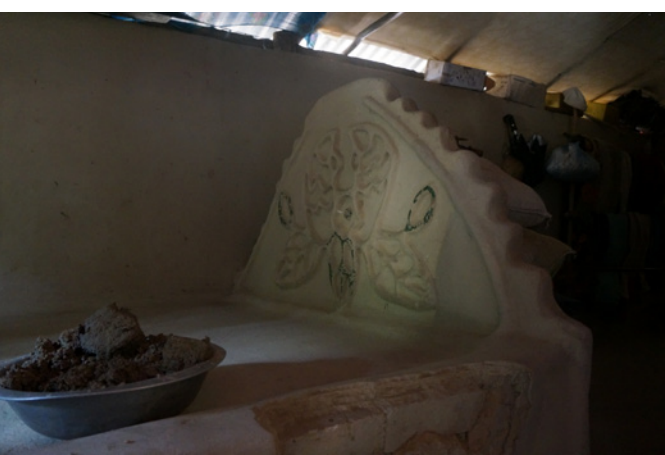
*Mud wall on platform, plastered with mud. Steps on the plinth respond to the different flooding risks*

*Drainage and local protection of mud wall with plastic sheet*

*Top:*  
 4 pitched thatched roof covered with plastic sheet  
*Left:*  
 4 pitched roof covered with CGI  
 Local salt storage covered with thatch  
 Maintenance of mud platform

NB: Some householders prefer to use polythene to “protect” the most exposed walls and plinths. This should be done only punctually (risk of humidity raising in the wall)

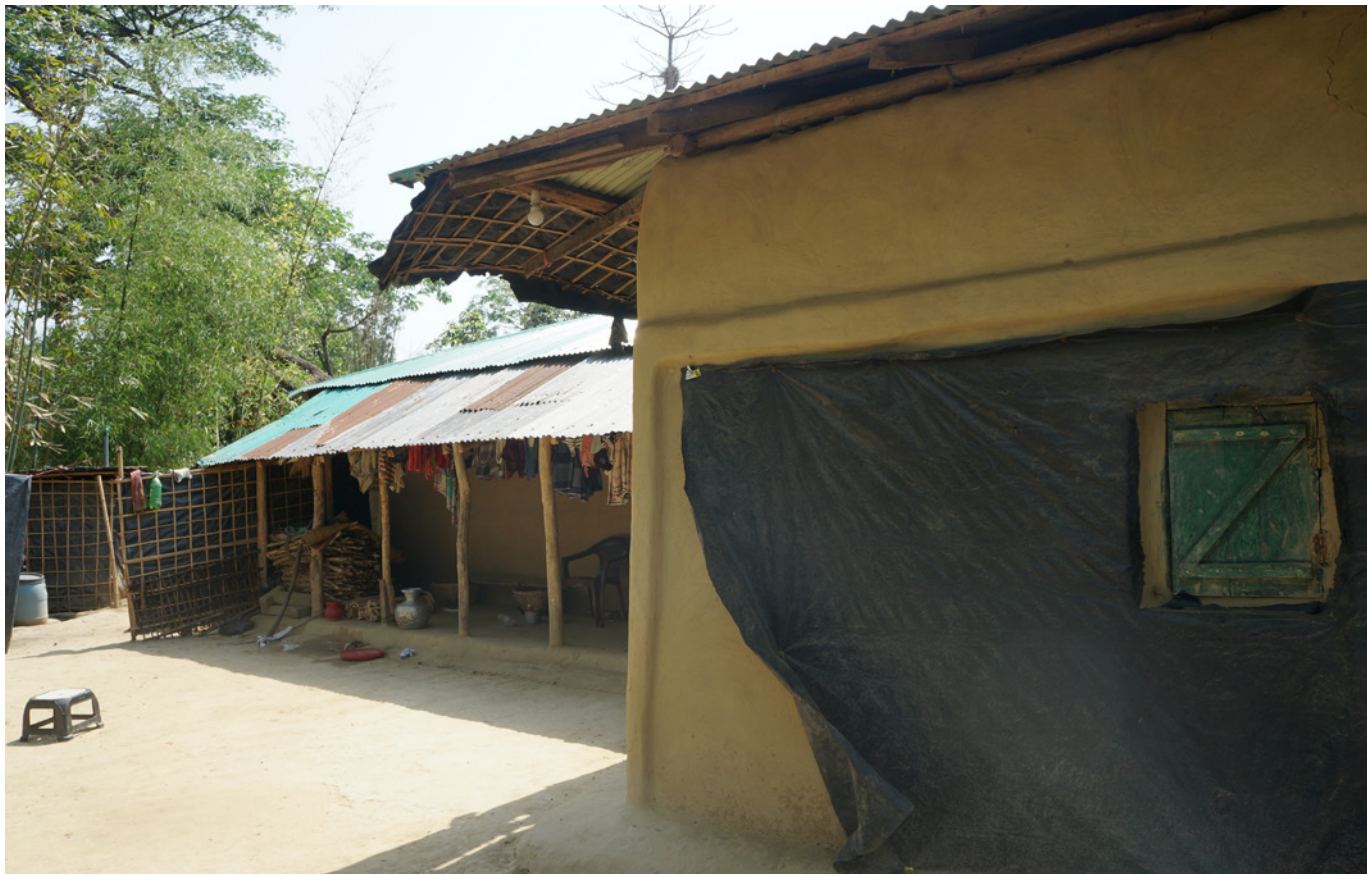
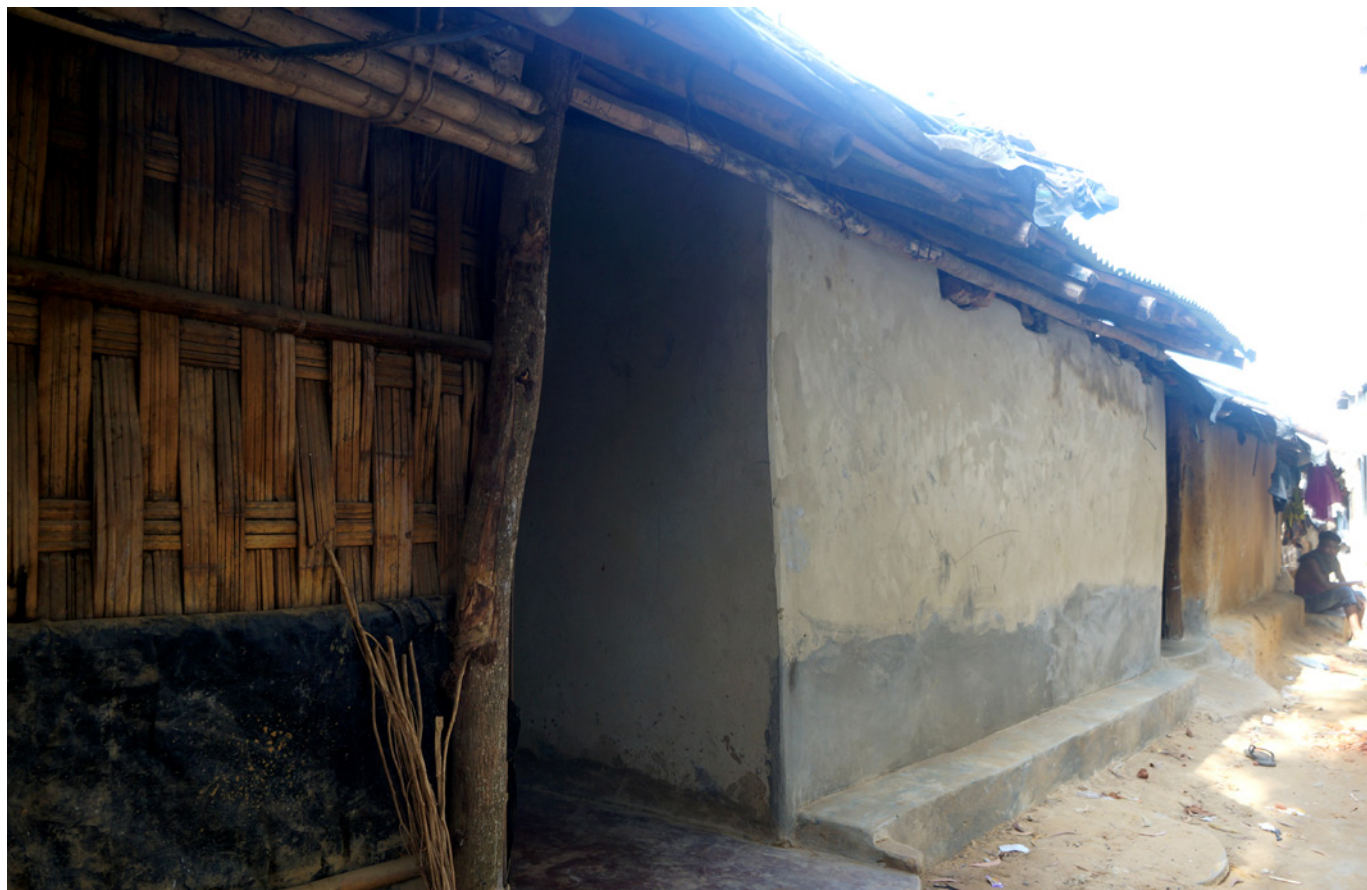
NB: use of cement stabilized plasters as protecting coating is not efficient (expensive for short time effect), as it is not very compatible with mud masonry and prevent the drying of the plinth due to the absence of any damp proof course in these constructions. Humidity accumulates in the mud plinth which reduces its durability, instead of increasing it, and the cement plaster rapidly dissociates from its support.

Top:  
Mud wall locally protected with plastic sheet, Mina Bazar  
host community

Bottom:  
Recent cement plaster on mud walls, Kutupalong registered  
camp

Mud walls are finished with mud plasters or lime plasters. It is not recommended to plaster mud walls with cement plaster because it increases the dampness of walls, making them more vulnerable. Plasters should permit drying of the walls and vapour diffusion.

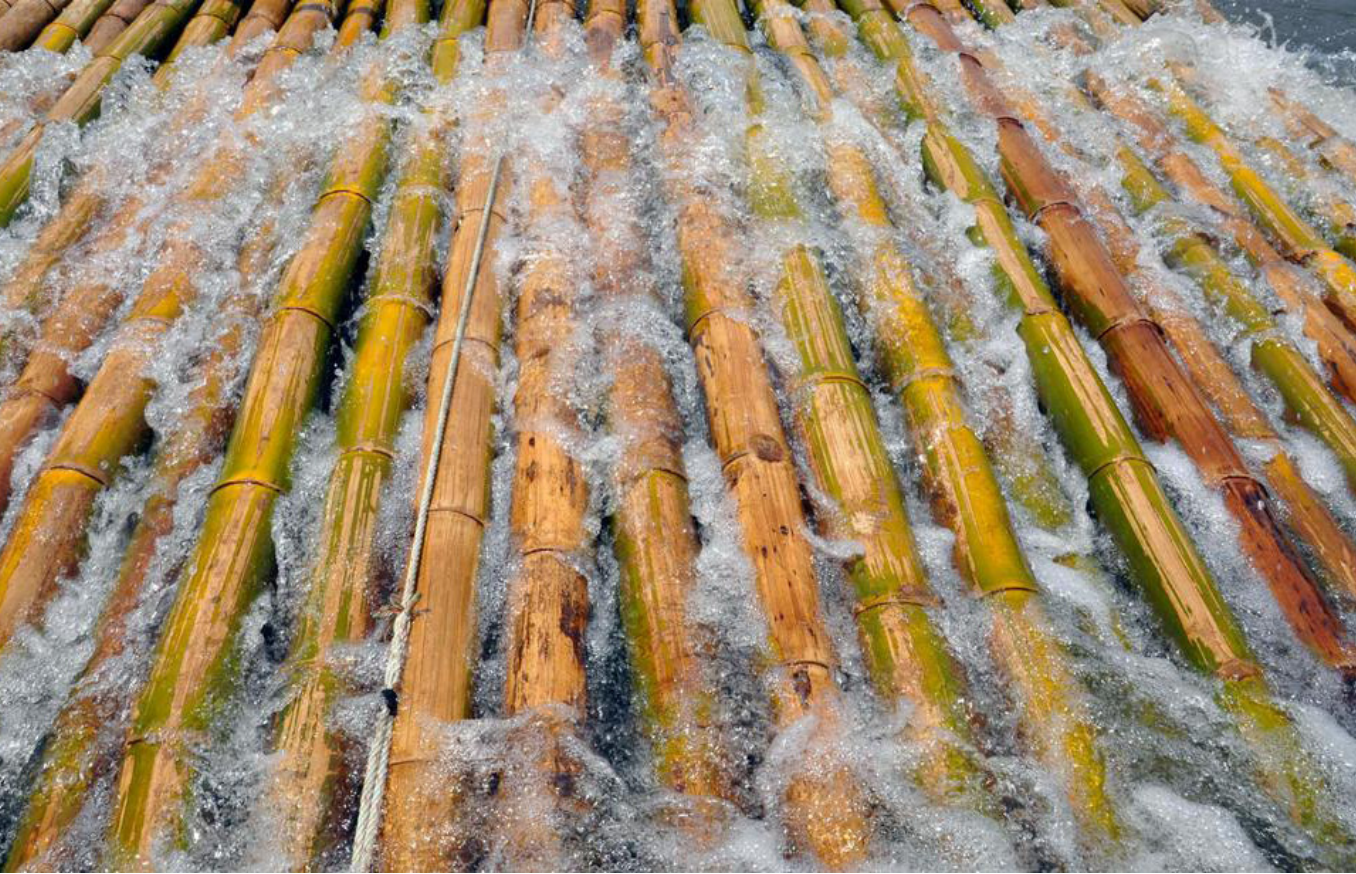
top  
water treatment: bamboo culms are drawn in water.  
bottom  
Natural coating applied on bamboo mat

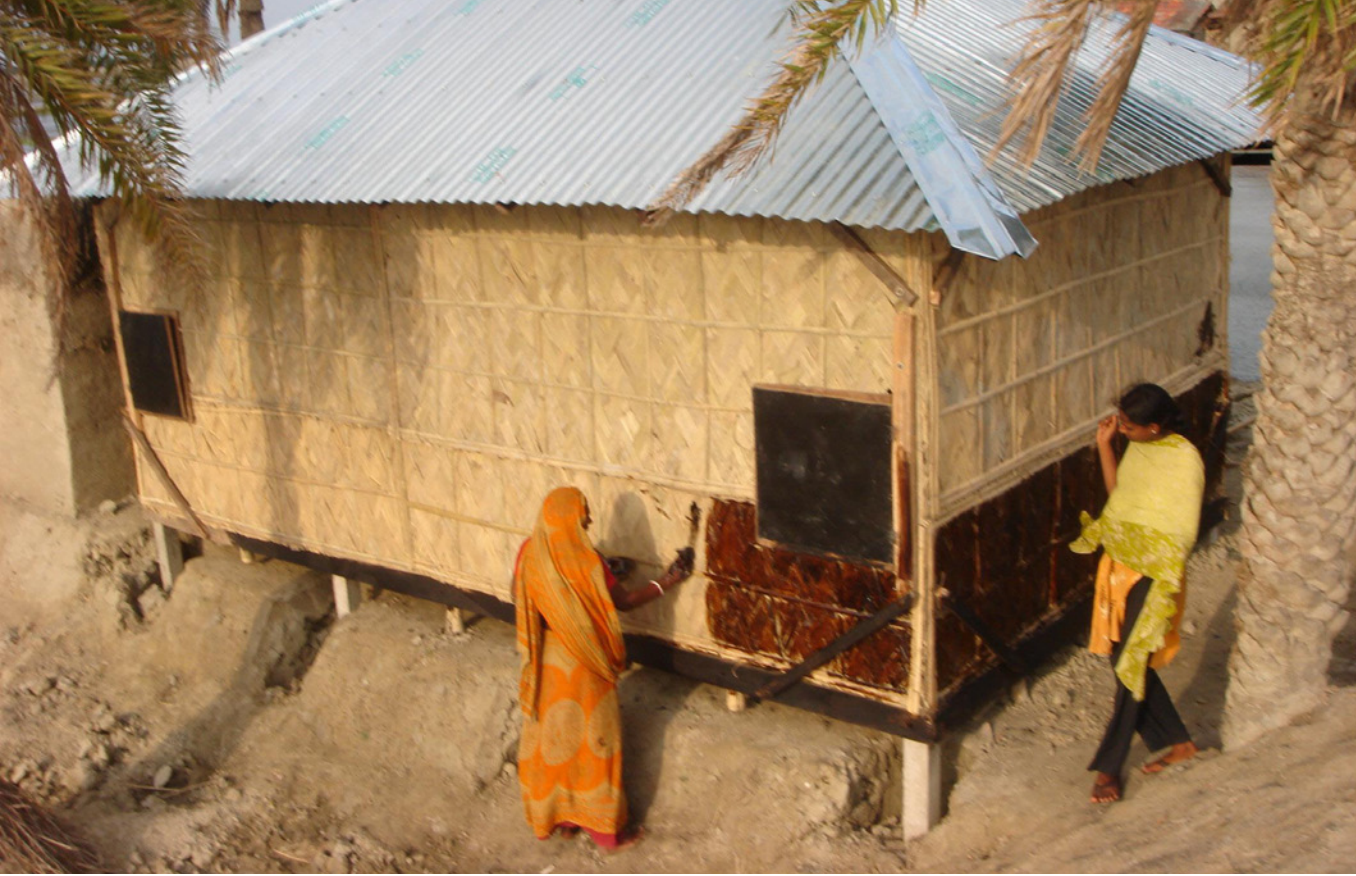
Top :  
Protection of bamboo fence, on most exposed part, Kuatala  
Bottom:  
Drilling holes in the bamboo culms facilitate the treatment  
(photo: Chiangmai Life Construction)
